## TEST REPORT

No. : XMIN2305001007ML01\_EN

Sample Name : 66# STANILESS STEEL HOOK

Product or Lot No. : WQ-SH-66

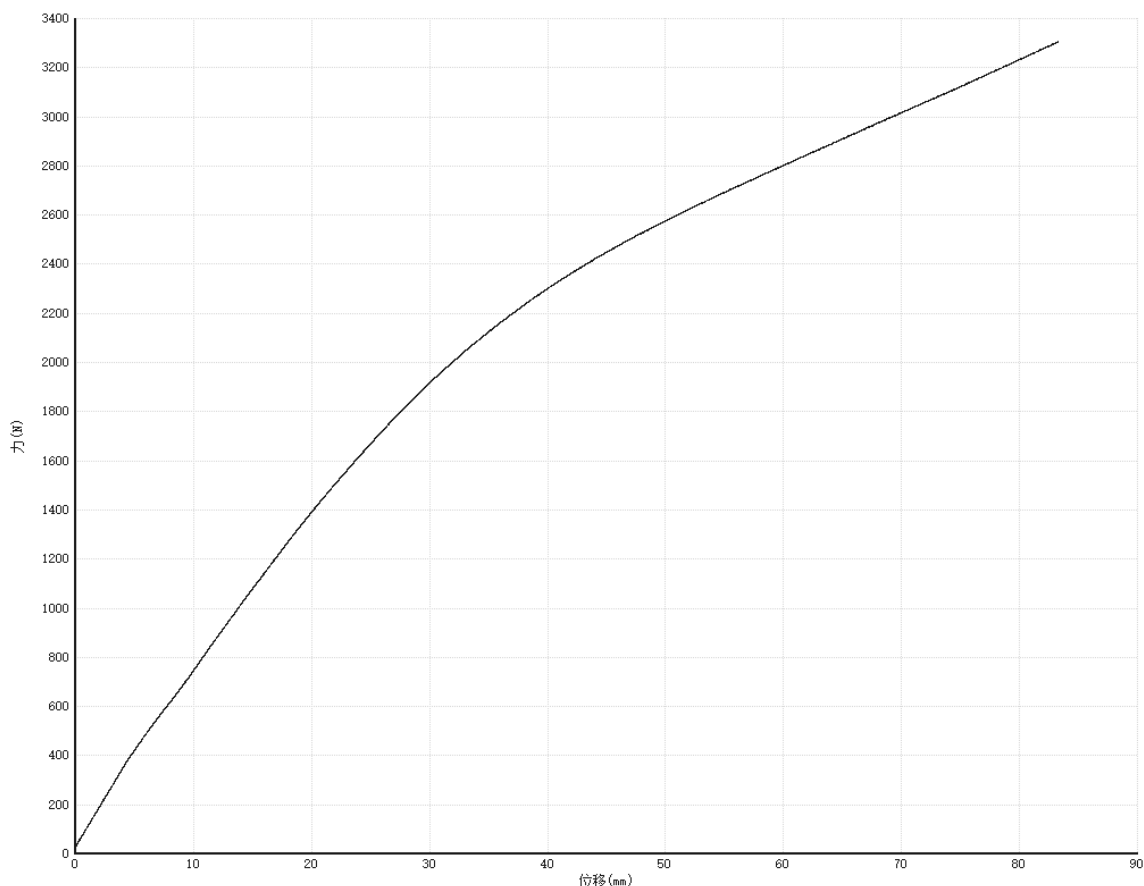
Force-displacement curve

Test method: according to the client's requirements, fix sample on the base as photo 1-2. Apply upward force as a speed of 10mm/min till the sample appears obvious deformation. Record the force and displacement.

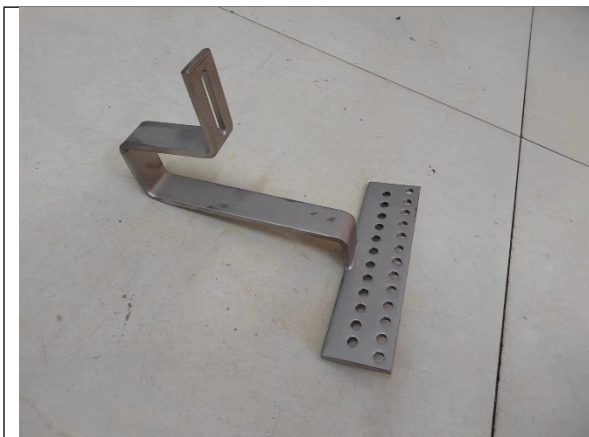
Photo 1-1: sample before test

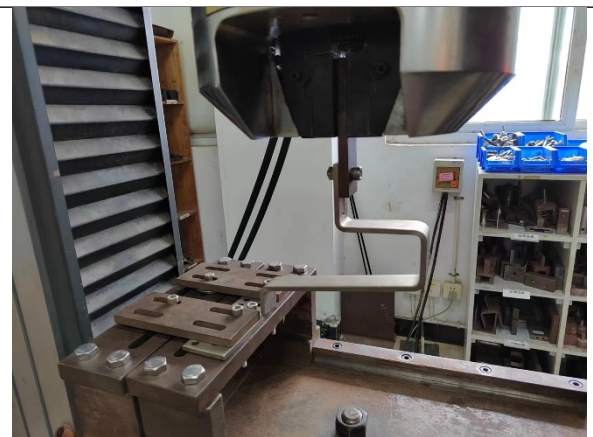
Photo 1-2: before loading

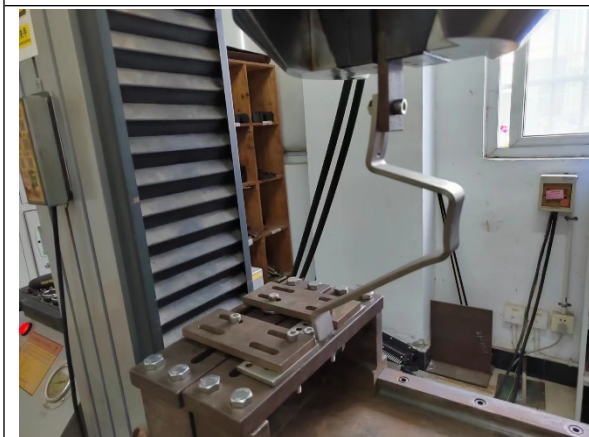
Photo 1-3: during the test

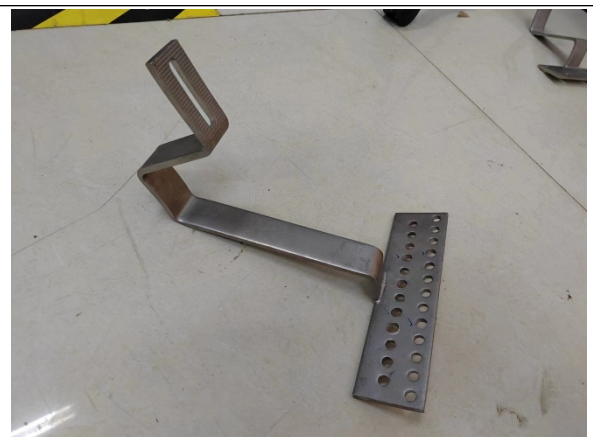
Photo 1-4: the sample after test

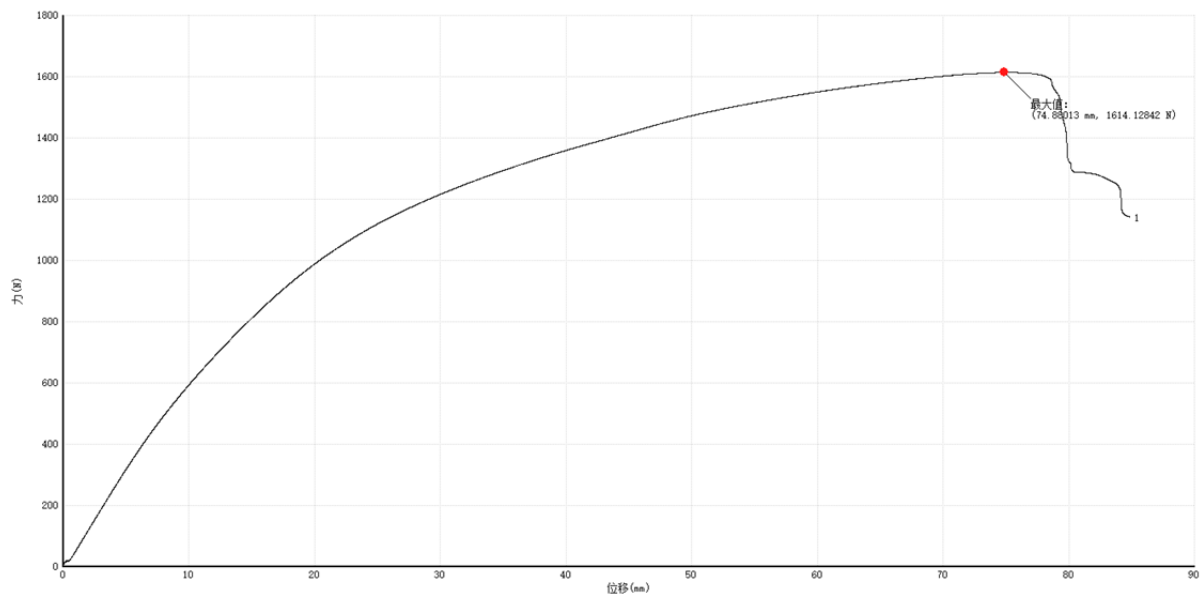
Force-displacement curve

Test method: according to the client's requirements, fix sample on the base as photo 2-2. Apply compress force as a speed of 10mm/min till the sample appears obvious deformation. Record the maximum force.

| Test item | Maximum force (N) |
|---|---|
| Compression test | 1614 |

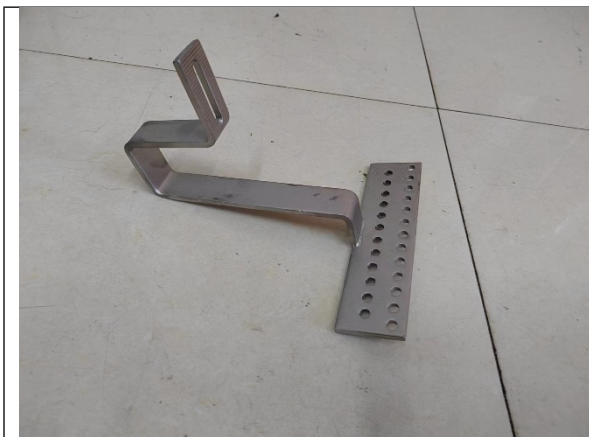
Photo 2-1: sample before test

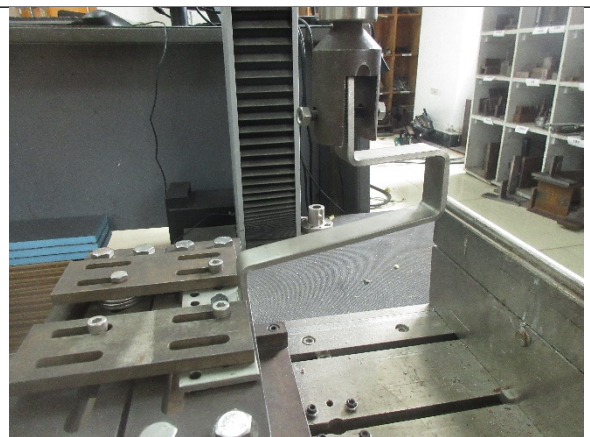
Photo 2-2: before loading

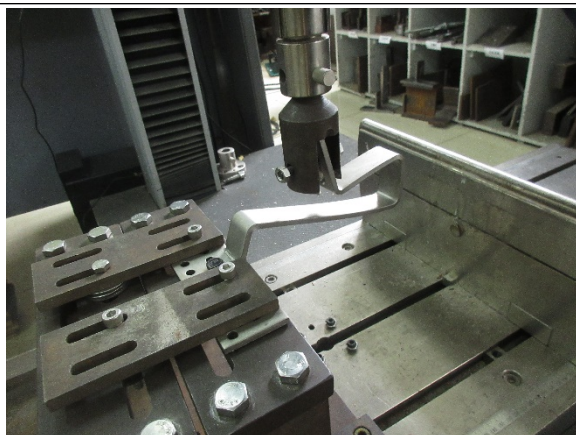
Photo 2-3: during the test

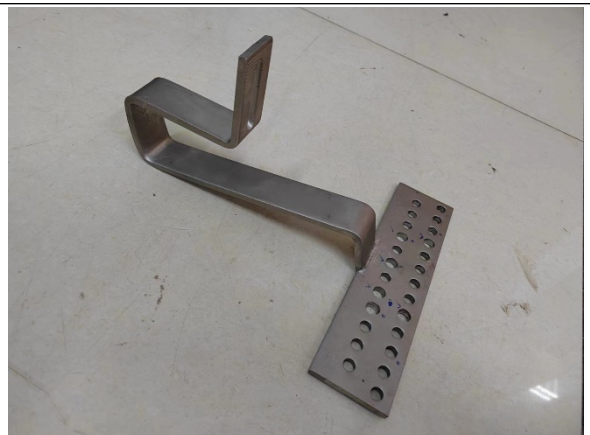
Photo 2-4: the sample after test
